## CONCOURS D'ACCÈS AU CORPS DE PROFESSEURS DE LYCÉE PROFESSIONNEL AGRICOLE

Section : **MARITIME**

Option : **ELECTROTECHNIQUE ET ELECTRONIQUE MARITIMES**

**SESSION 2025**

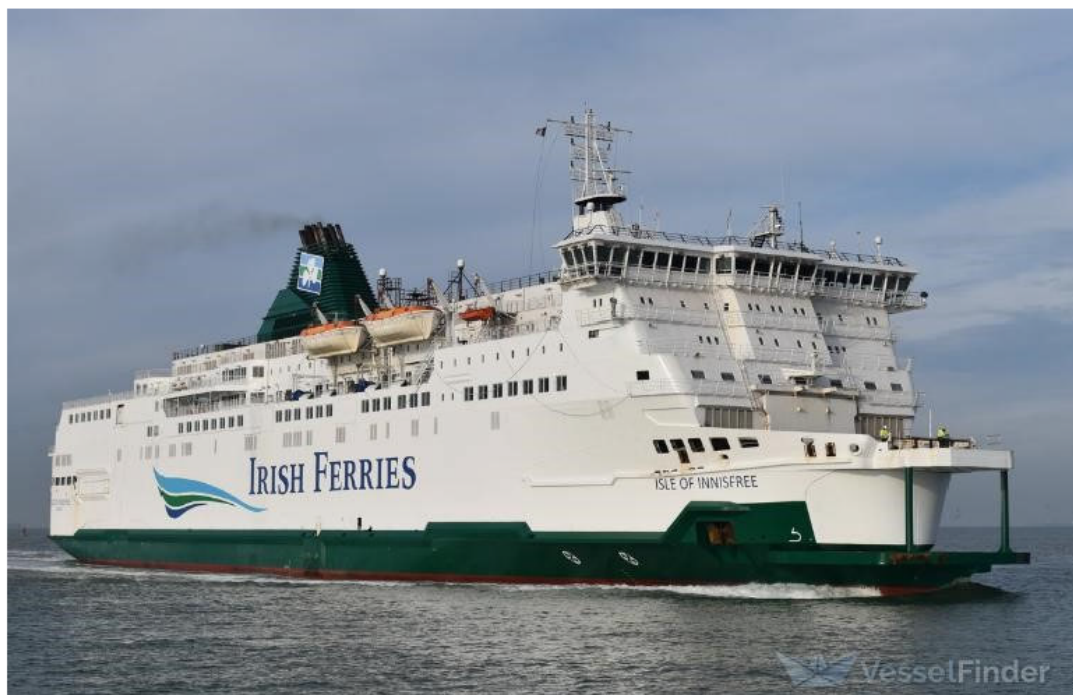
Figure 3 - Source : website VesselFinder

La plage avant de l'ISLE OF INNISFREE est constituée d'une plate-forme sans chaumards reposant, à son extrême avant, sur deux épontilles (cf. figure 3).

Cette configuration présente un fort risque d'avaries, qui pourraient être provoquées par la pantoire du remorqueur, en cas d'embarquées au cours d'un remorquage en haute mer.
