**CONCOURS D'ACCÈS AU CORPS DE PROFESSEURS DE LYCÉE PROFESSIONNEL  
AGRICOLE**

Option : **MÉCANIQUE NAVALE**

**SESSION 2025**

MARINE INCIDENT

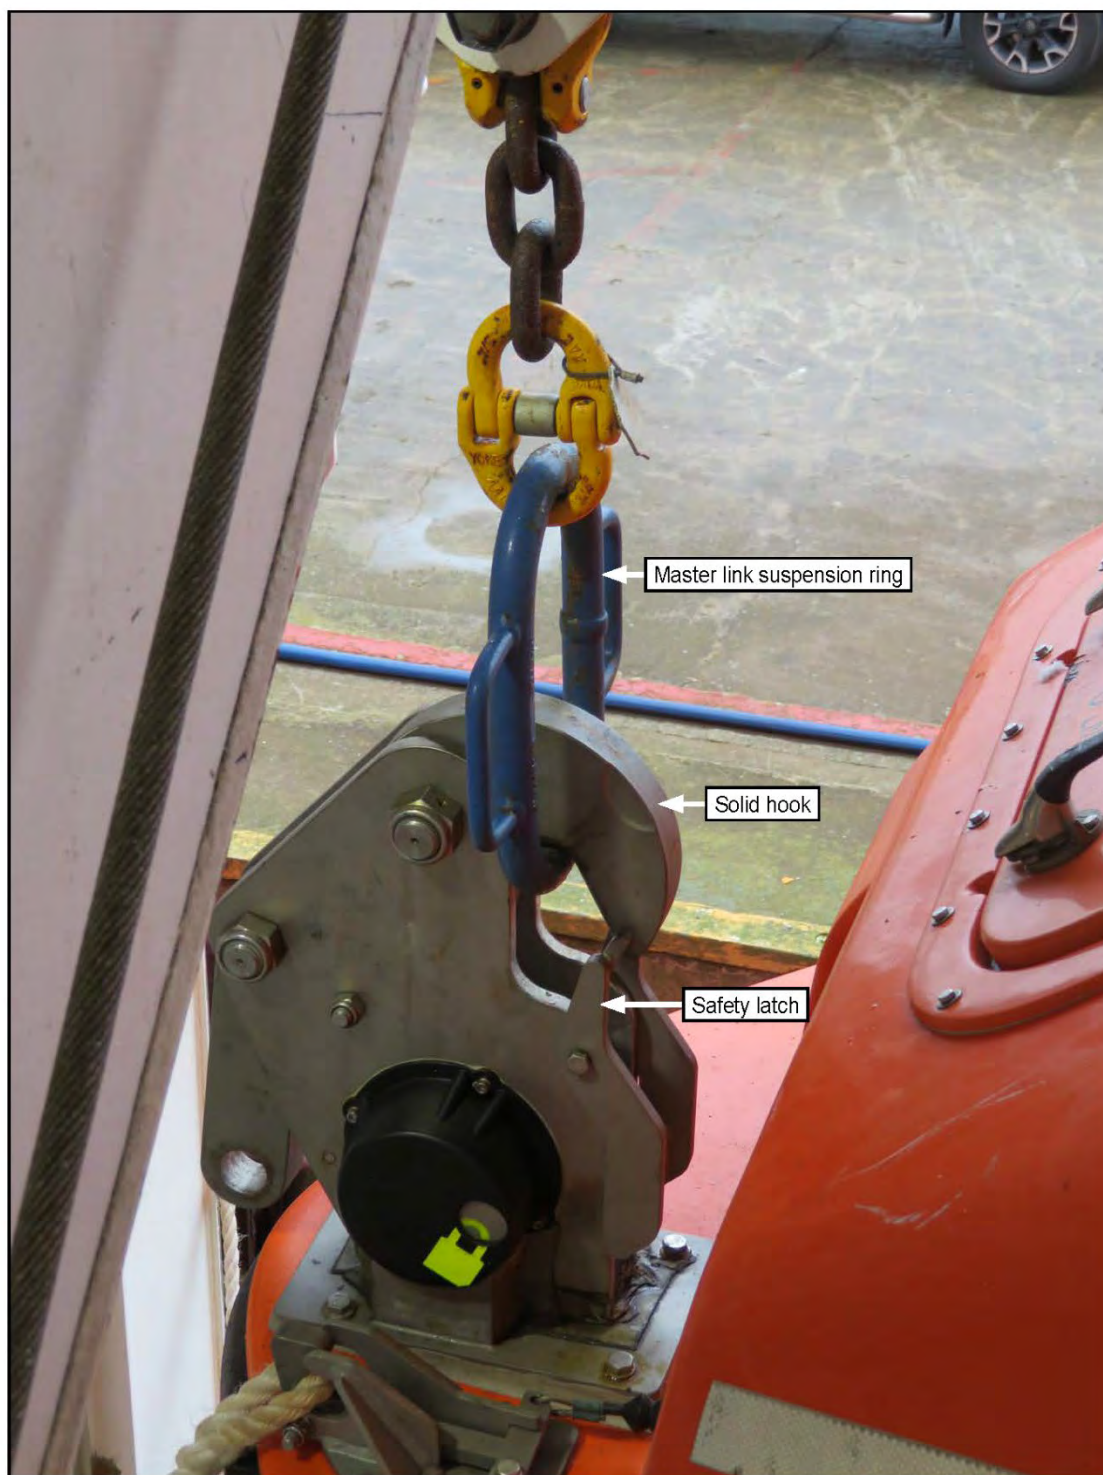
Figure 10: Lifeboat hook and master link suspension ring

The safety latches of both lifeboat hooks sustained damage when the master link suspension rings<sup>9</sup> on the davit falls (**Figure 10**) disengaged from the hooks as the lifeboat rolled onto its side and fell to the water. The damaged safety latches were replaced after the accident and the lifeboat hooks were load tested.

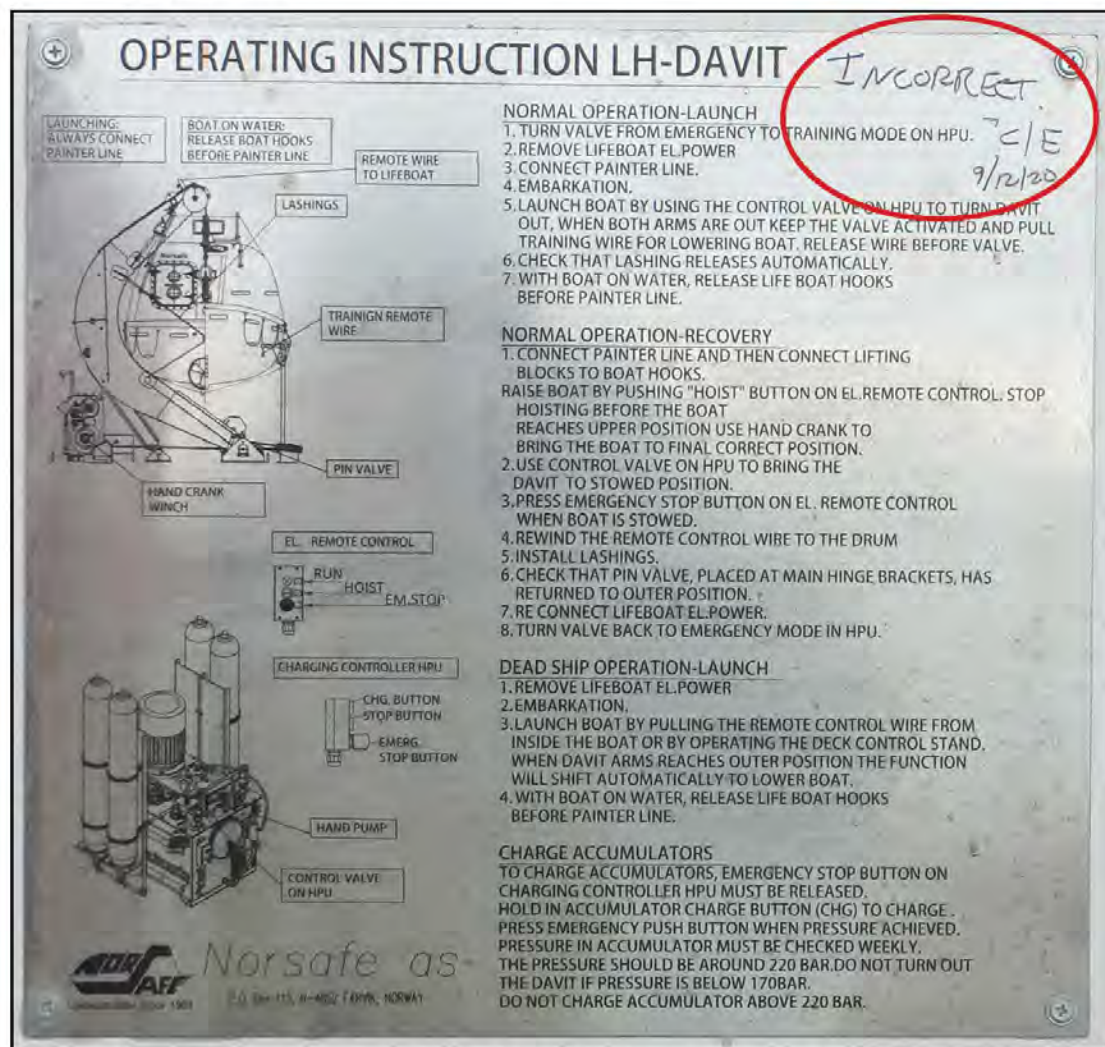
Figure 11: Instruction plates fitted adjacent to lifeboat davits, showing the handwritten statement

December 2020 (**Figure 11**). The Norsafe manual stated that safety checks were to be conducted after the davit operation, which included ensuring that the interlock cylinder piston rod was fully extended over the winch brake operating arm.
